Glass Strength in Solar Applications

International Materials Institute

Tuesday, November 18, 2008

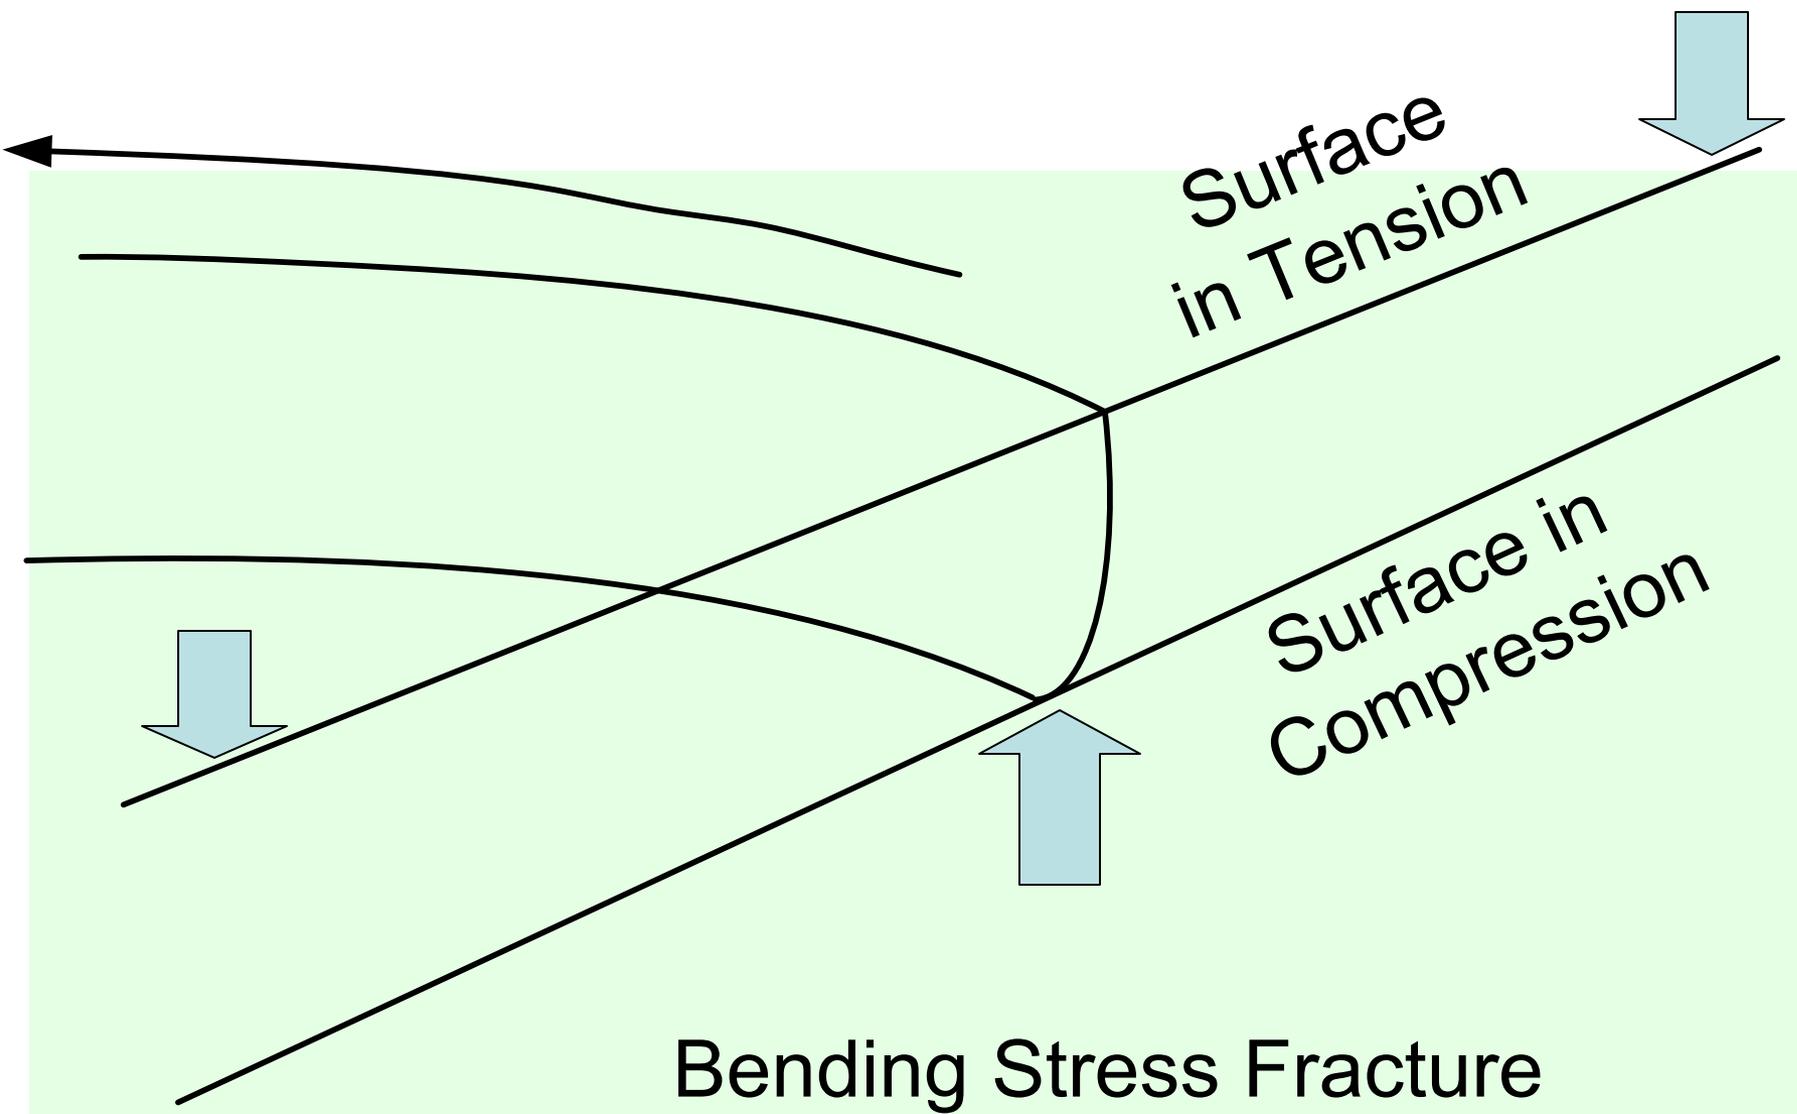
Bending Stress Fracture
Fracture starts in tension zone

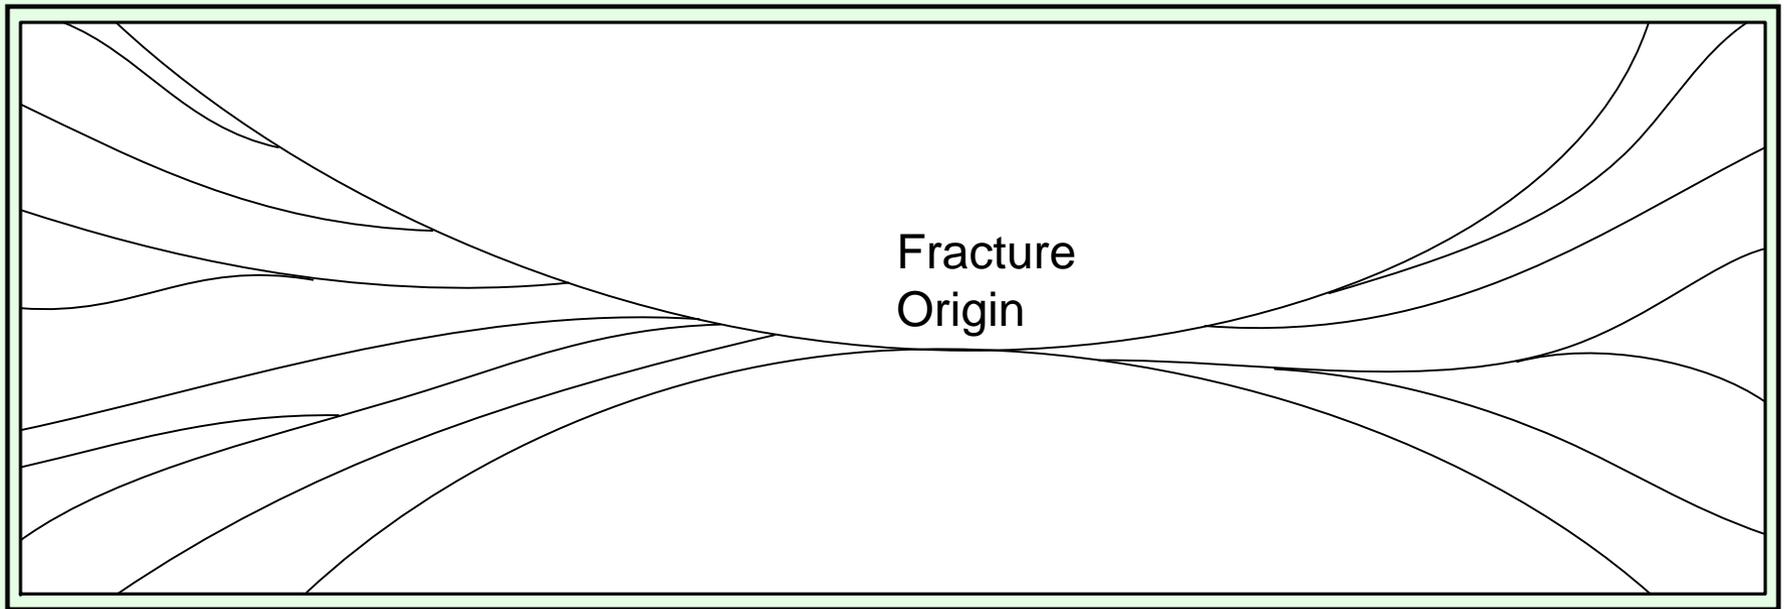
Properly glazed High Aspect Ratio Sealed Insulating Glass.
Breakage from too High or too Low air space pressure

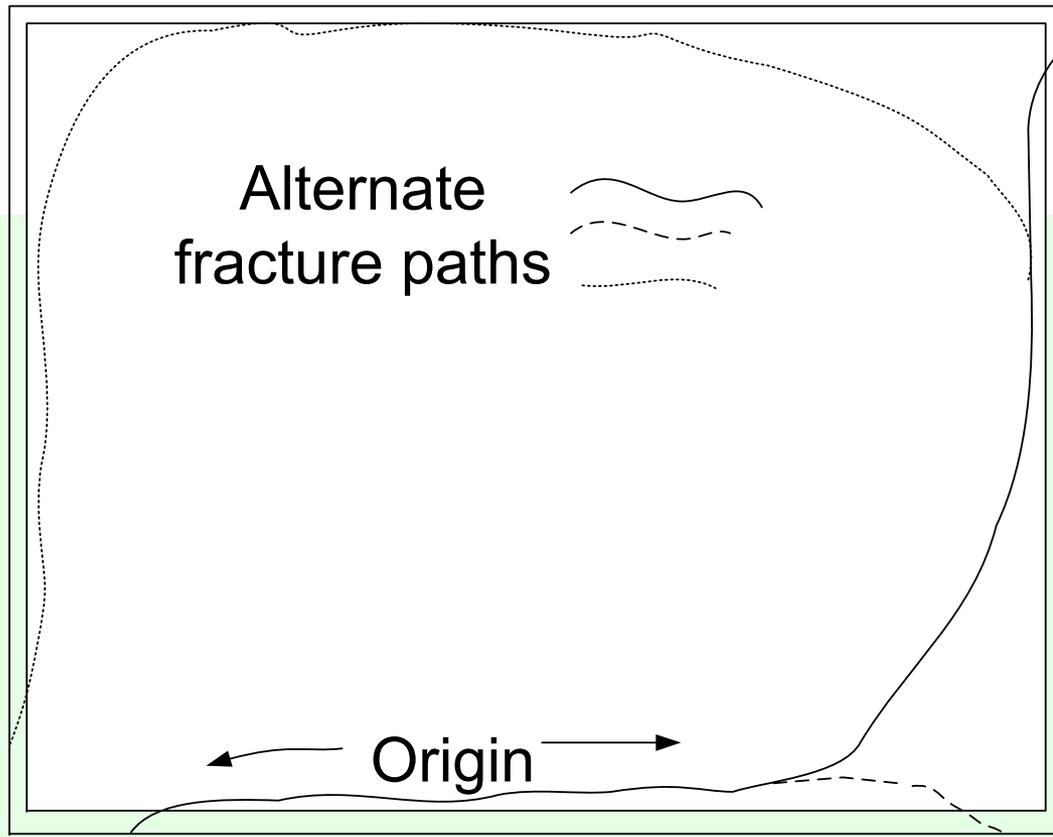
Incorrect 'Clamped Edges' create very high bending stresses at low temperatures in Insulating Glass. Fracture origin at a scratch.

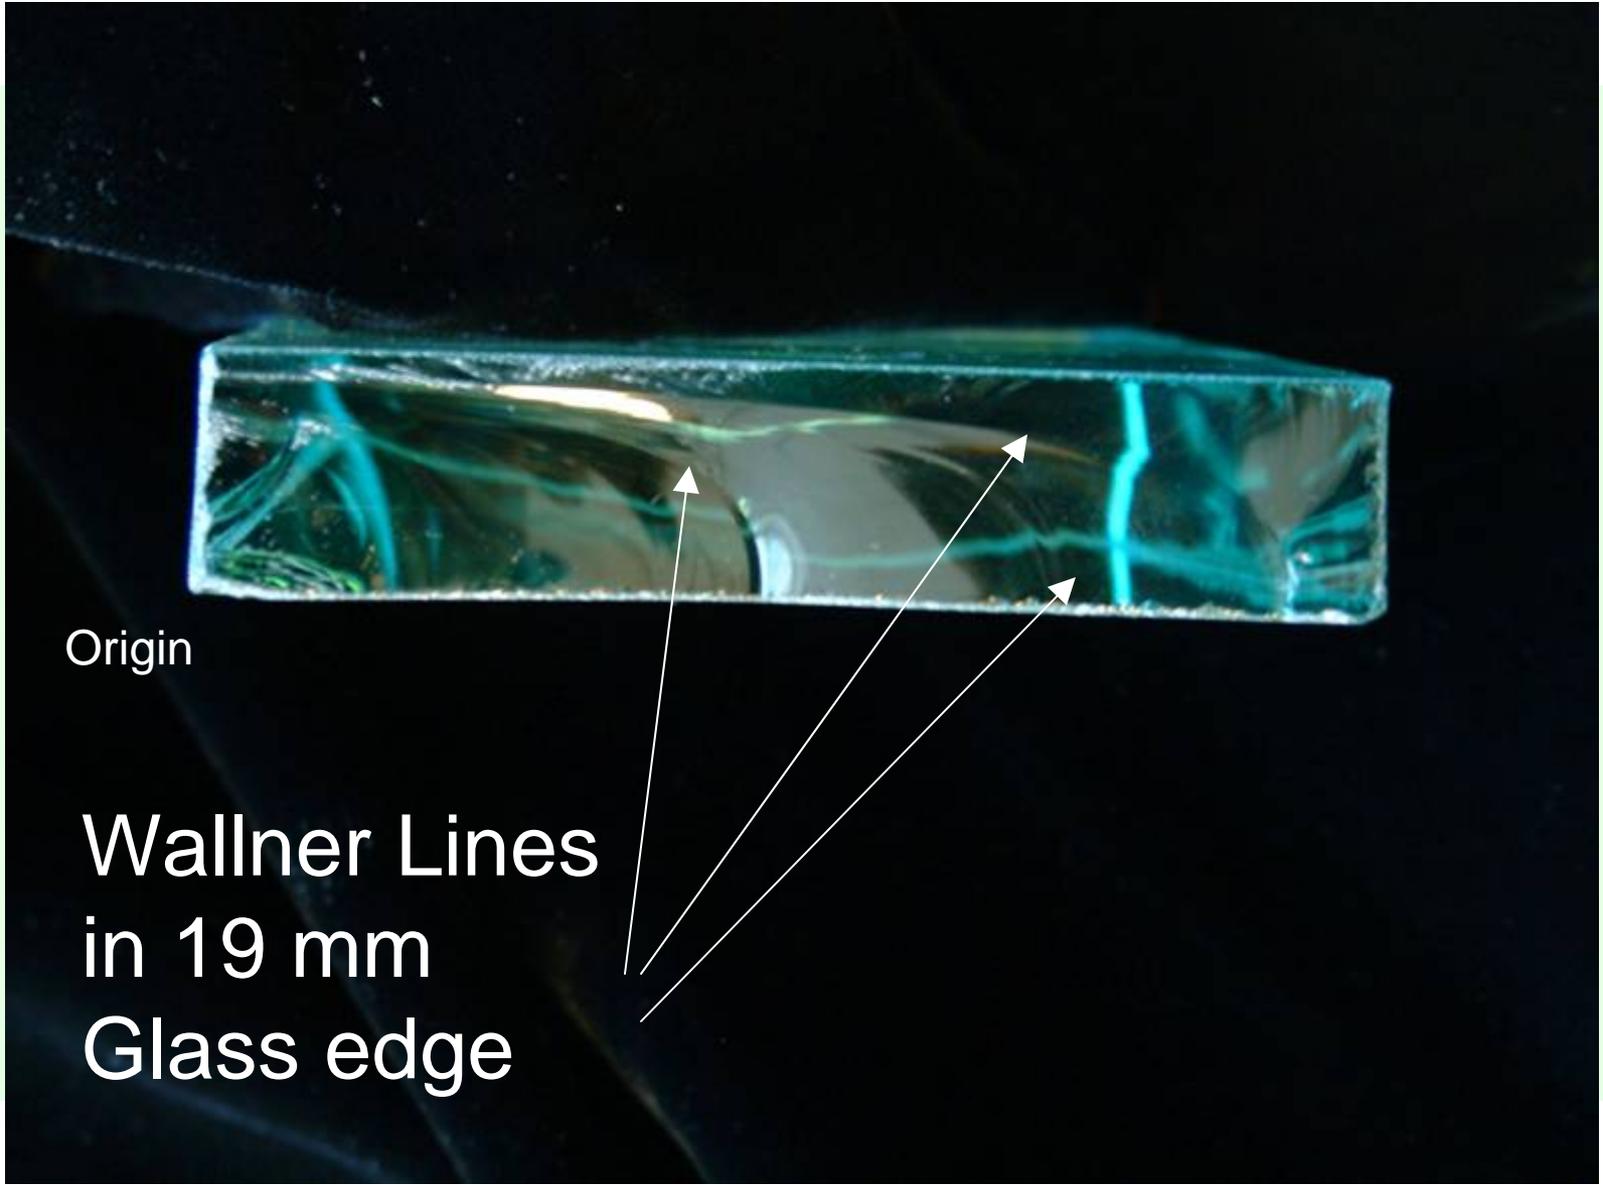
Origin

Wallner Lines
in 19 mm
Glass edge

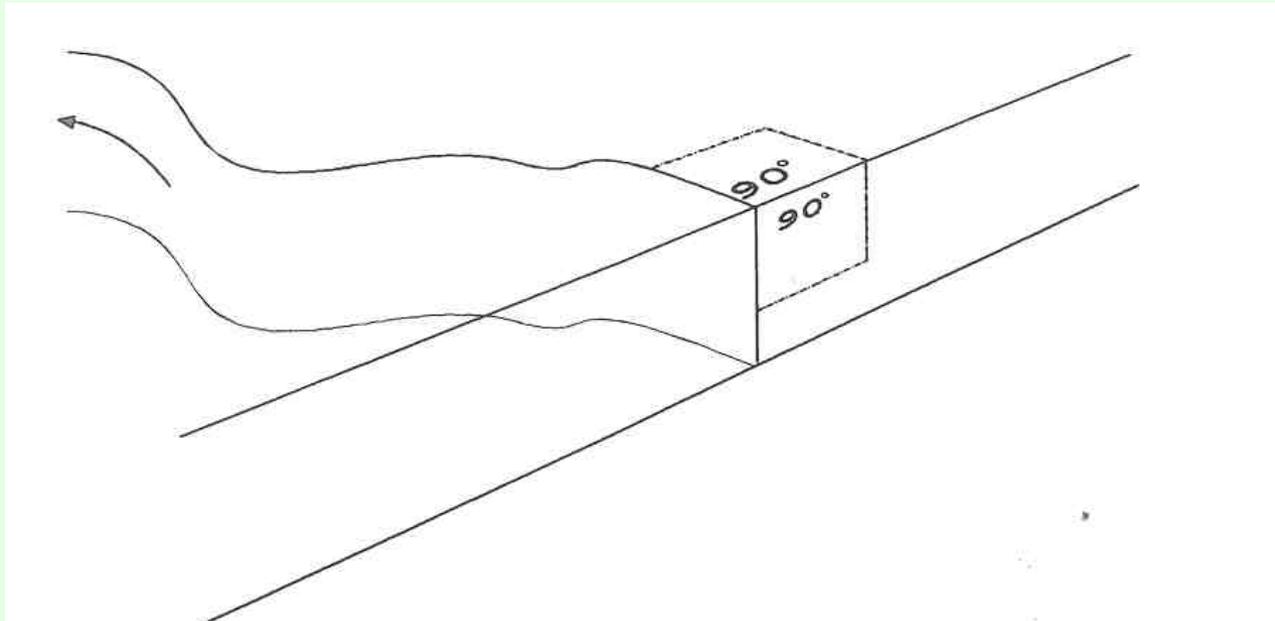
Classic Thermal Stress fracture origin.

Break typically starts in the central $\frac{3}{4}$ of the edge length and not at a corner.

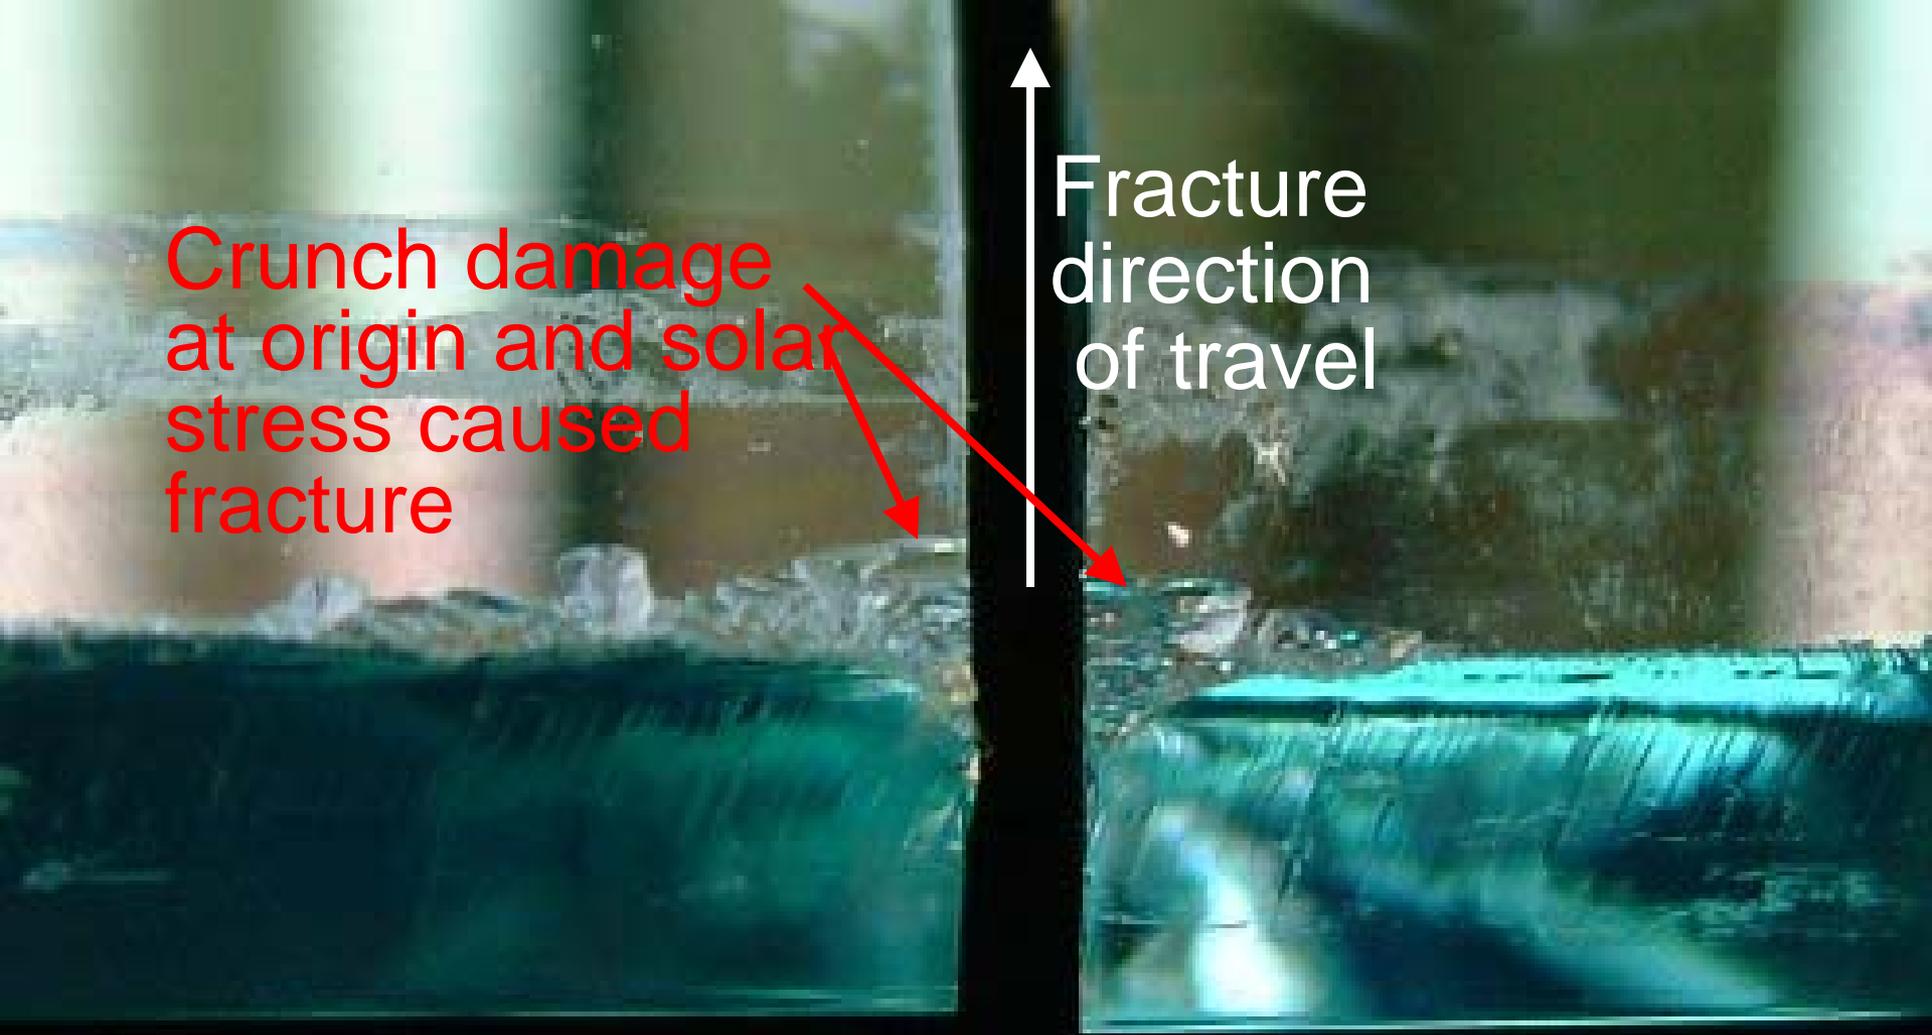
Crunch damage at origin and solar stress caused fracture

Fracture direction of travel

Cut edge – poor quality

Solar E (solar absorbing Low E coating) incorrectly used on #3 Surface (should be #2).

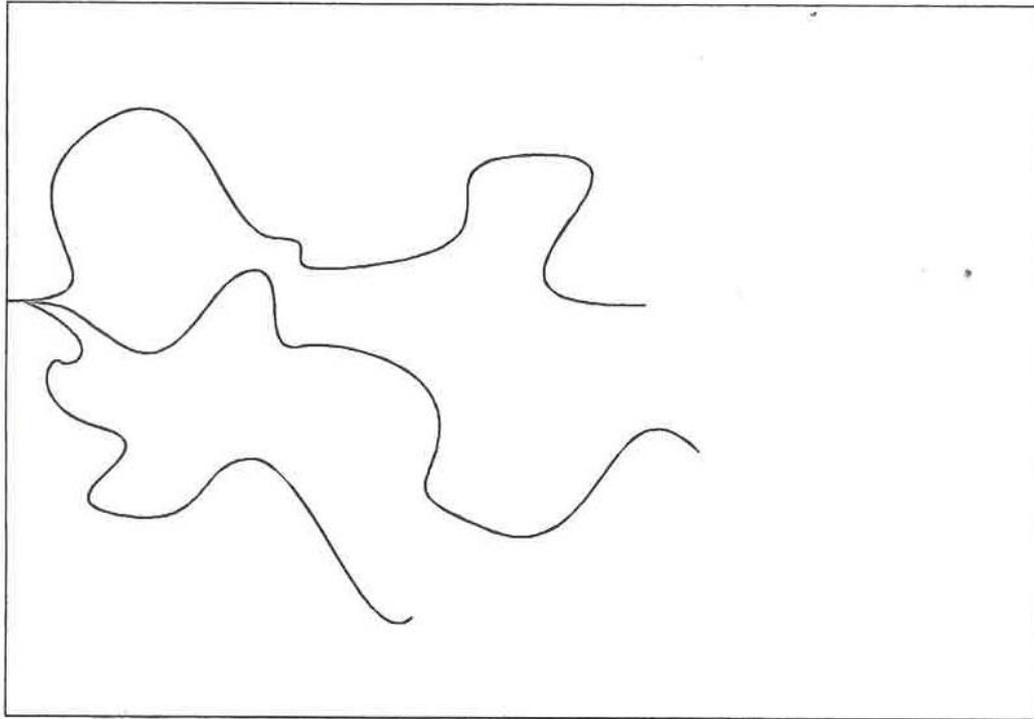
High Stress: Multiple crack surfaces were needed to absorb excessive energy.

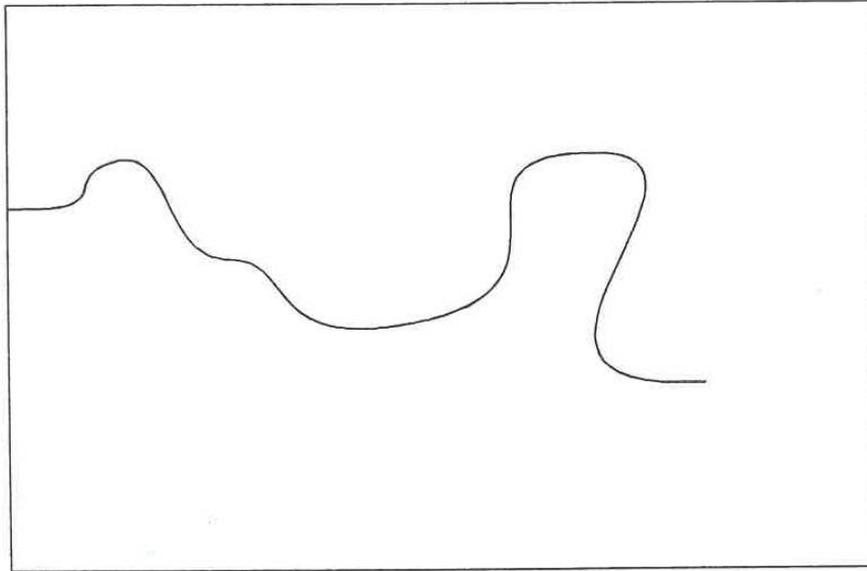
Low Stress: Single crack suggests a weaker glass edge. Less energy was needed to propagate the crack

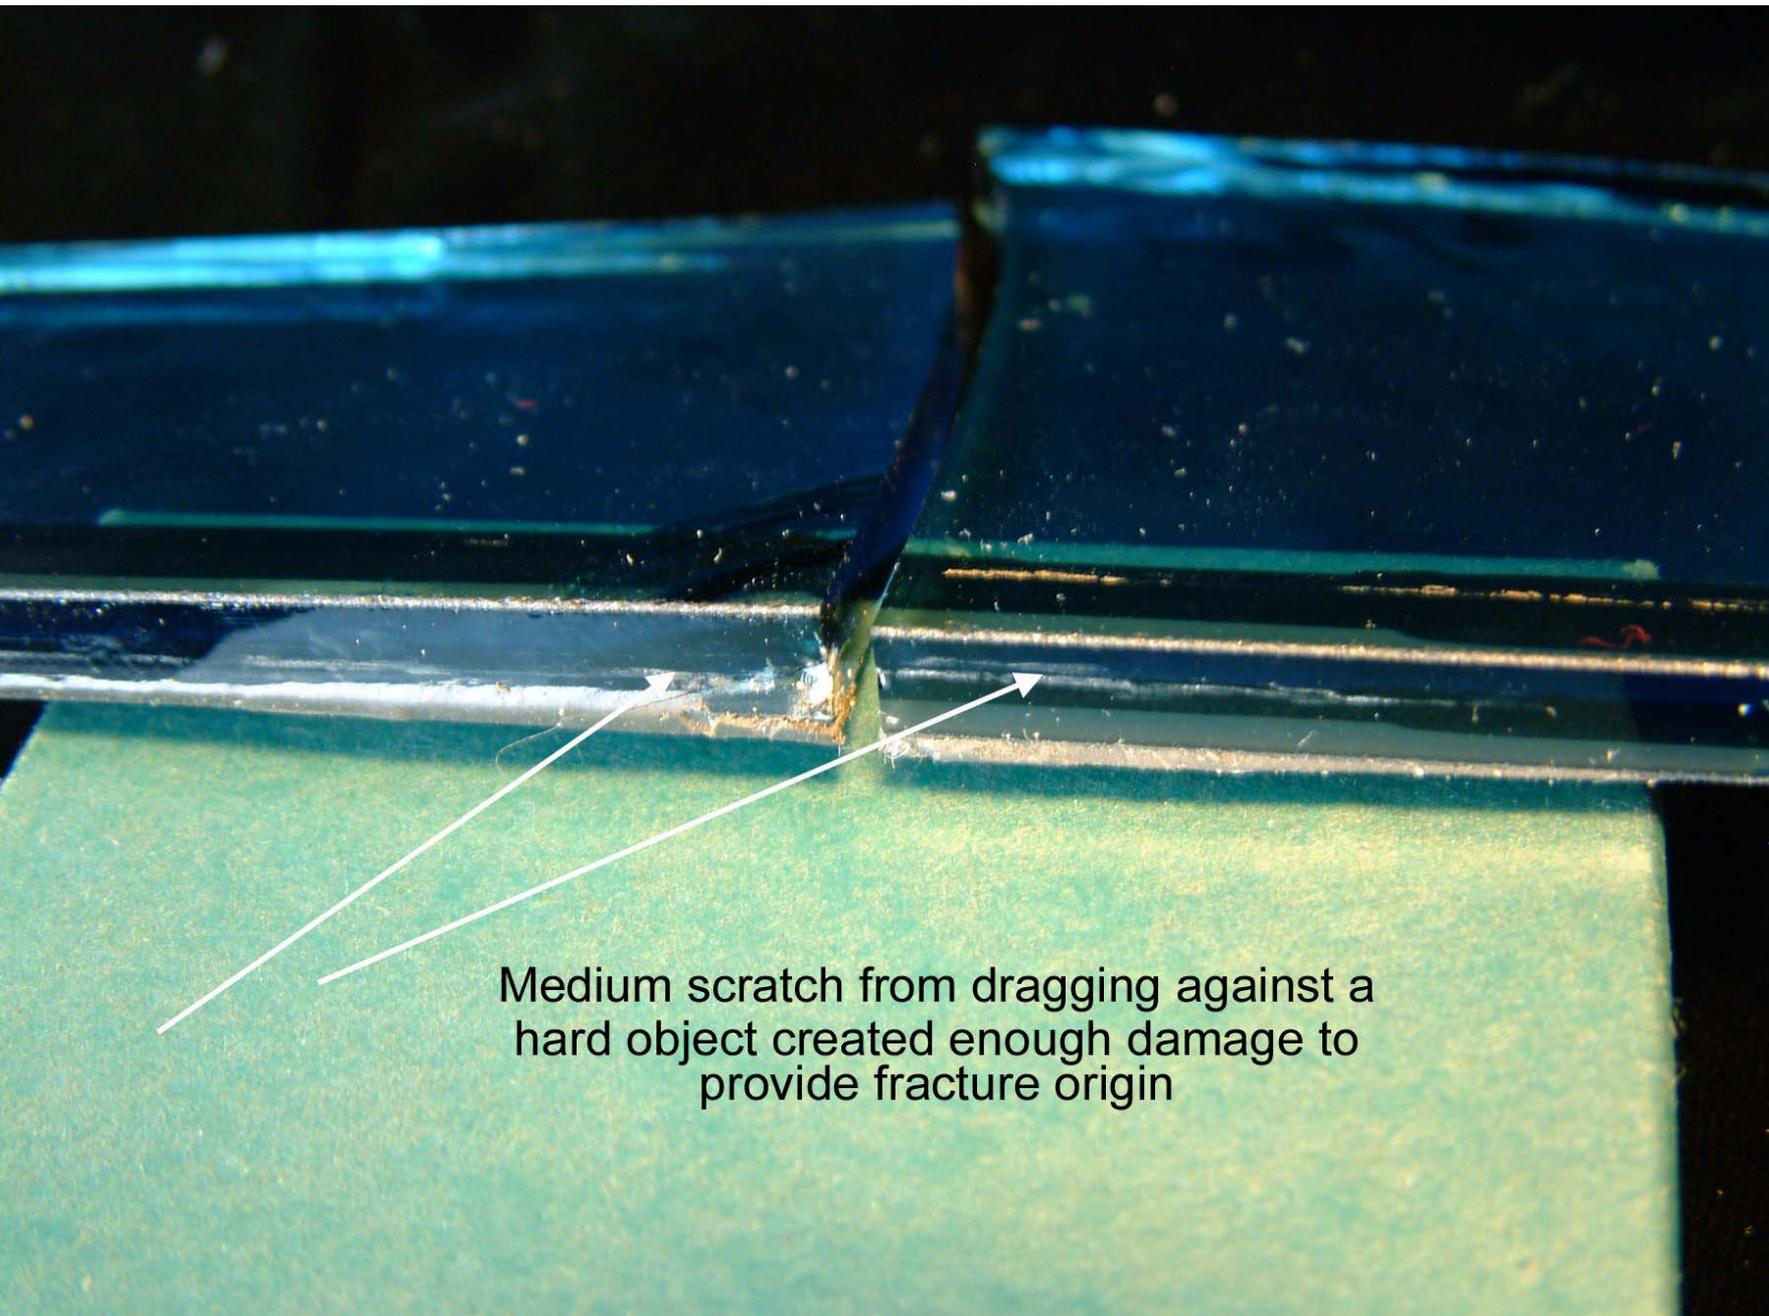
Medium scratch from dragging against a hard object created enough damage to provide fracture origin

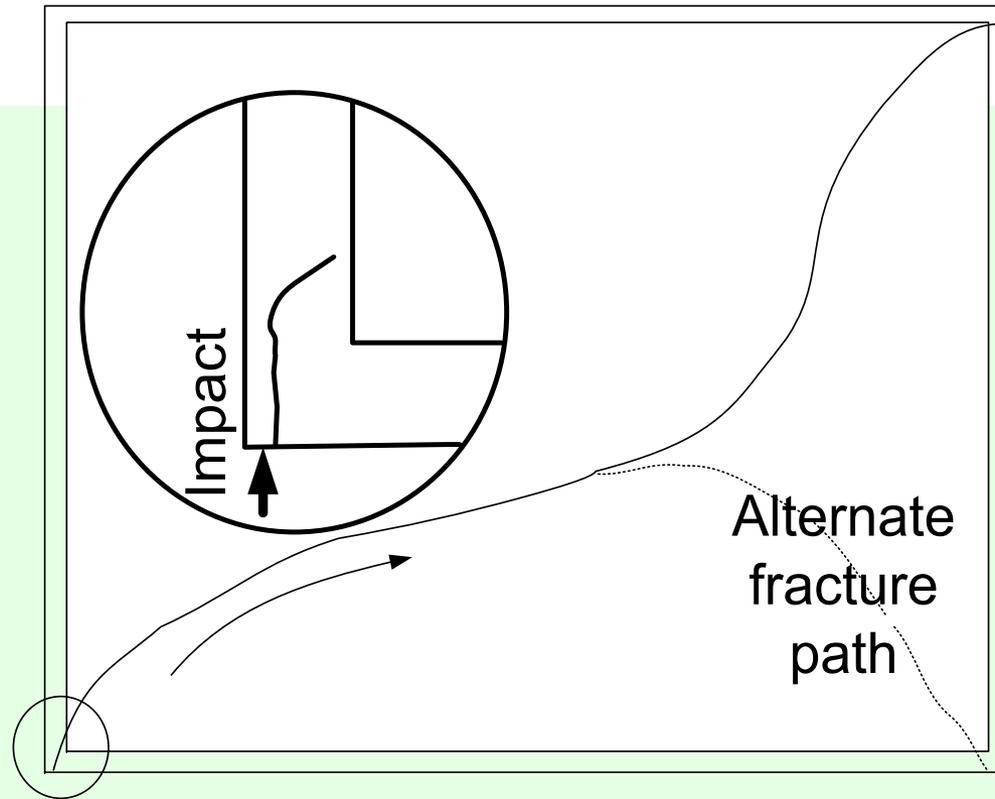
A corner impact easily creates a 10 or 20 mm long crack which waits for a high stress situation to make it run. Here low winter temperature contracts the sealed air space and creates a large bending stress.

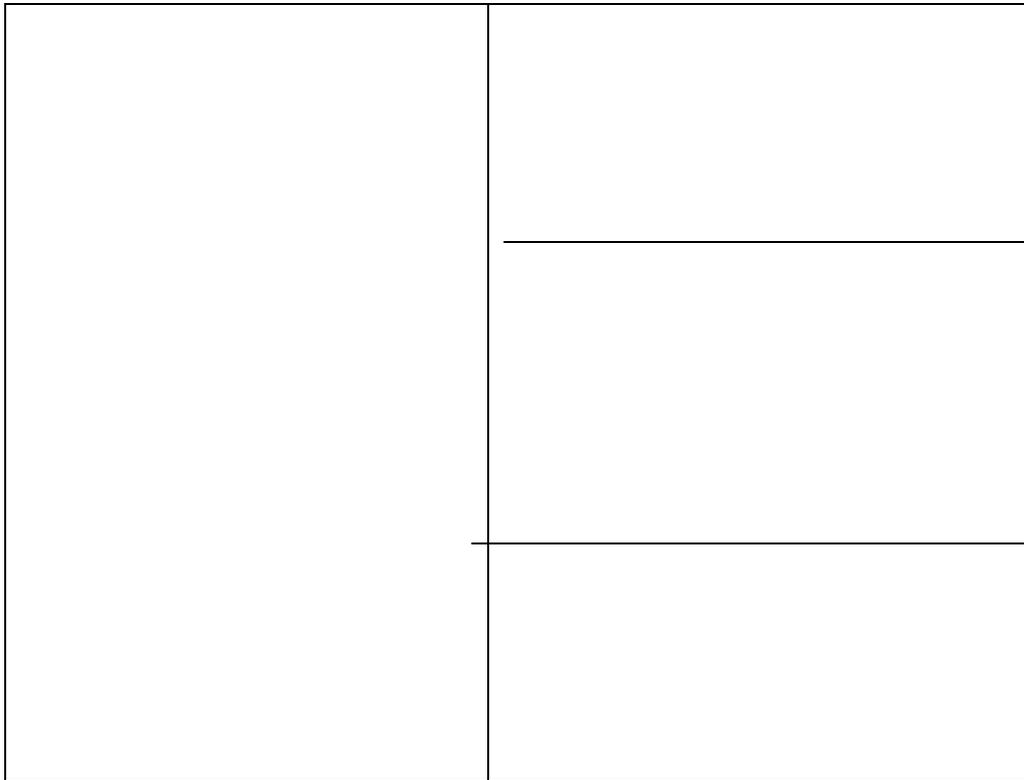
Over-running Interrupted Cut Score Line

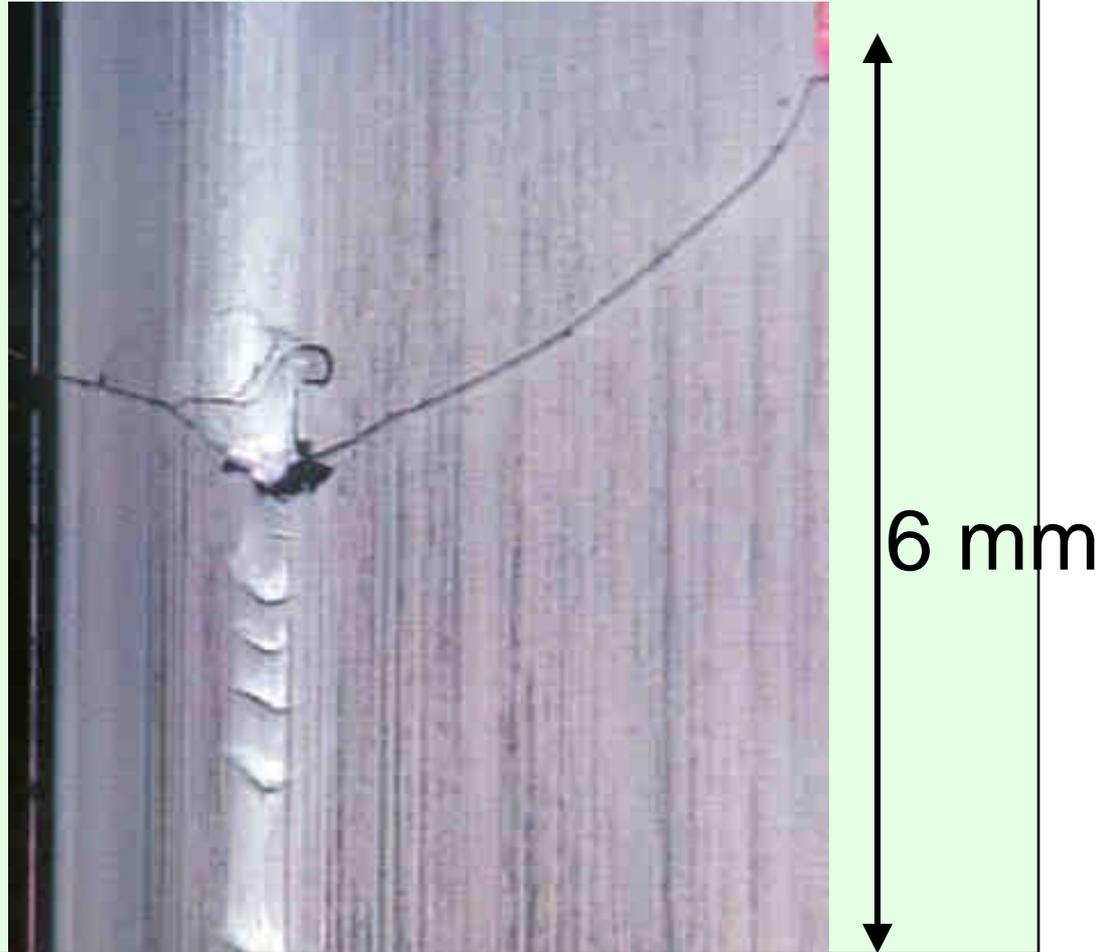
Fracture

Origin at rub
mark on IG cut
edge. Thermal
stress caused
the small vent
to run

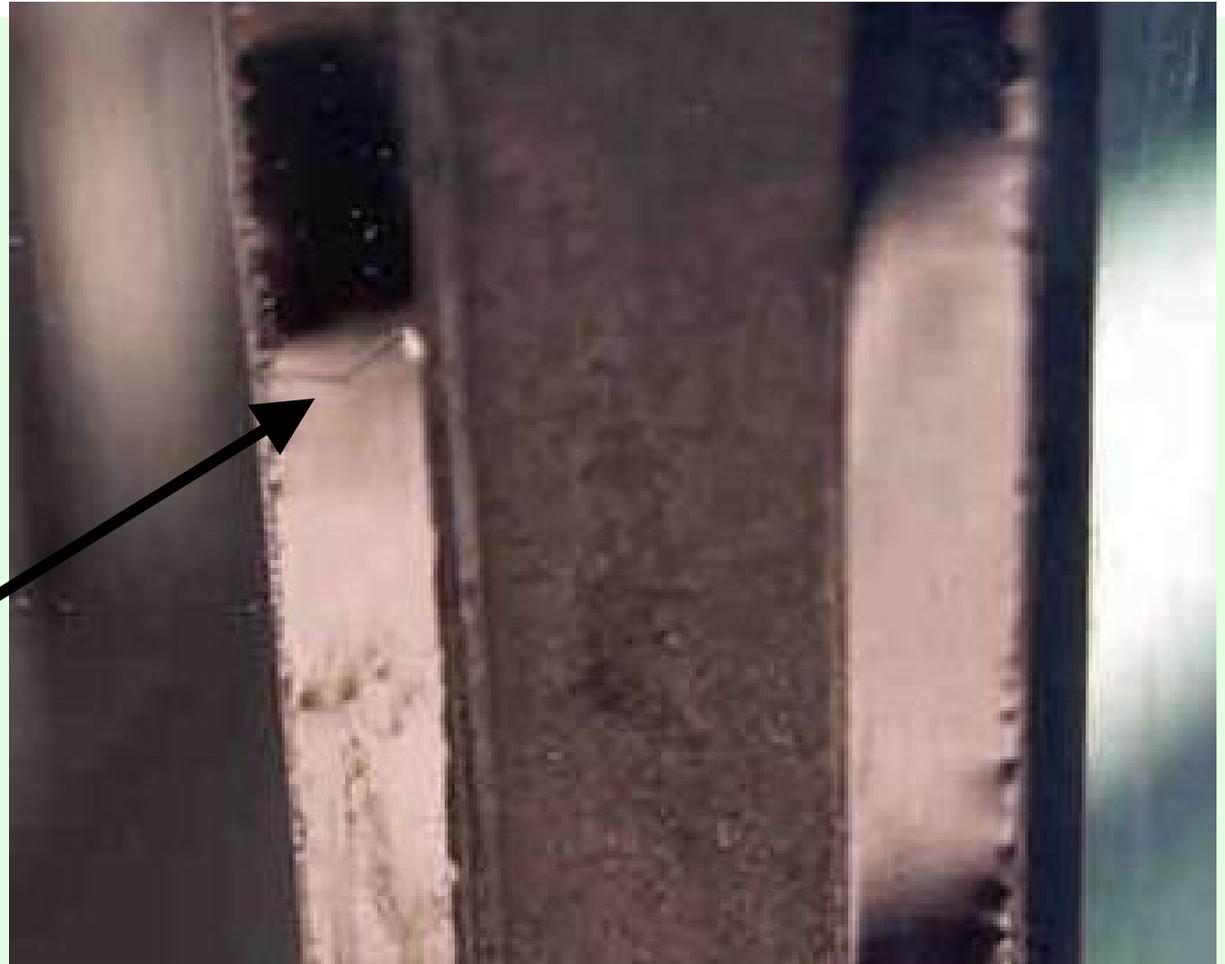
Tempered Glass

Fracture origin at
plate center

Look for surface
damage or very
small inclusion in
glass at origin

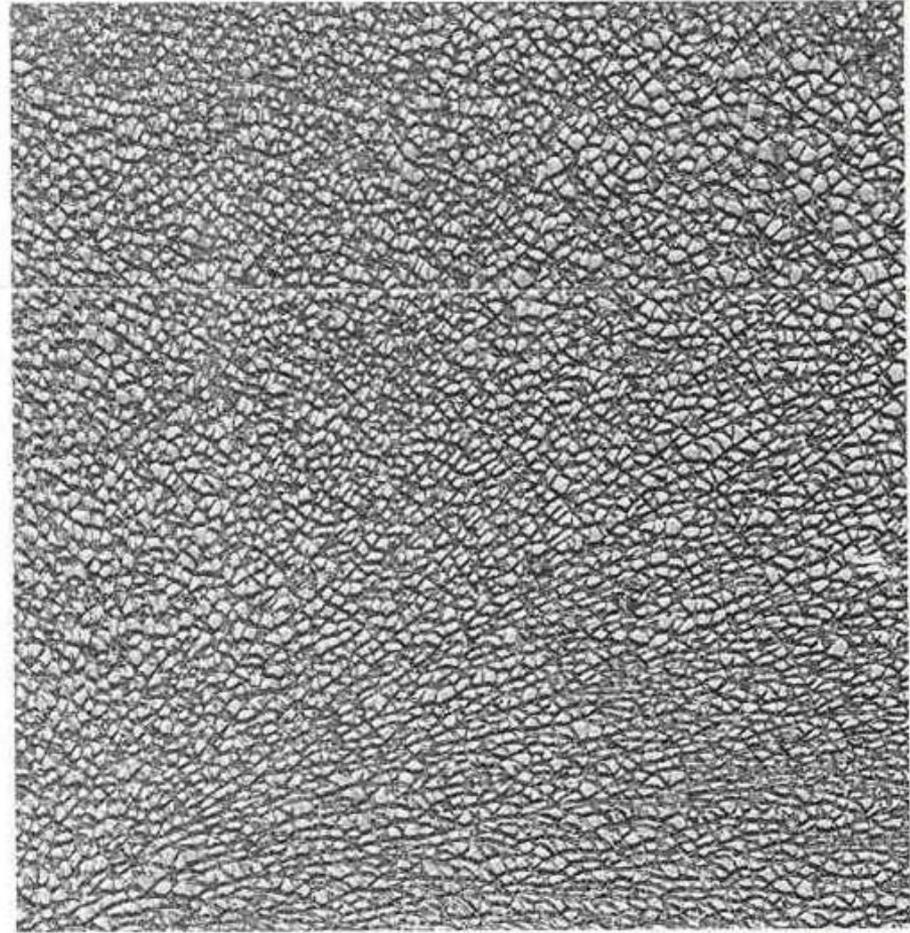
Tempered Glass

Corner origin of fracture.

Look for corner-crunch damage
