PCI / PITA RESEARCH PROJECT

Horizontal Shear Capacity of Composite Concrete Beams without Interface Ties

ATLSS REPORT NO. 08-05

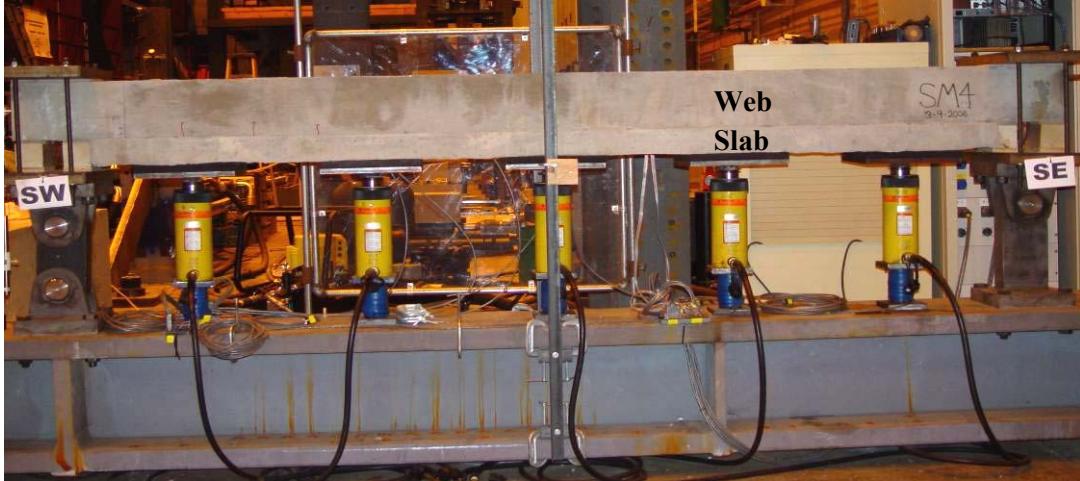
jacks serviced by a single hydraulic pump (Figure 5-7 and Figure 5-8). The applied load was paused every five kips in order to inspect the beam and the composite interface. The test was stopped once the specimen failed.

Figure 5-7: Five Point Load Configuration

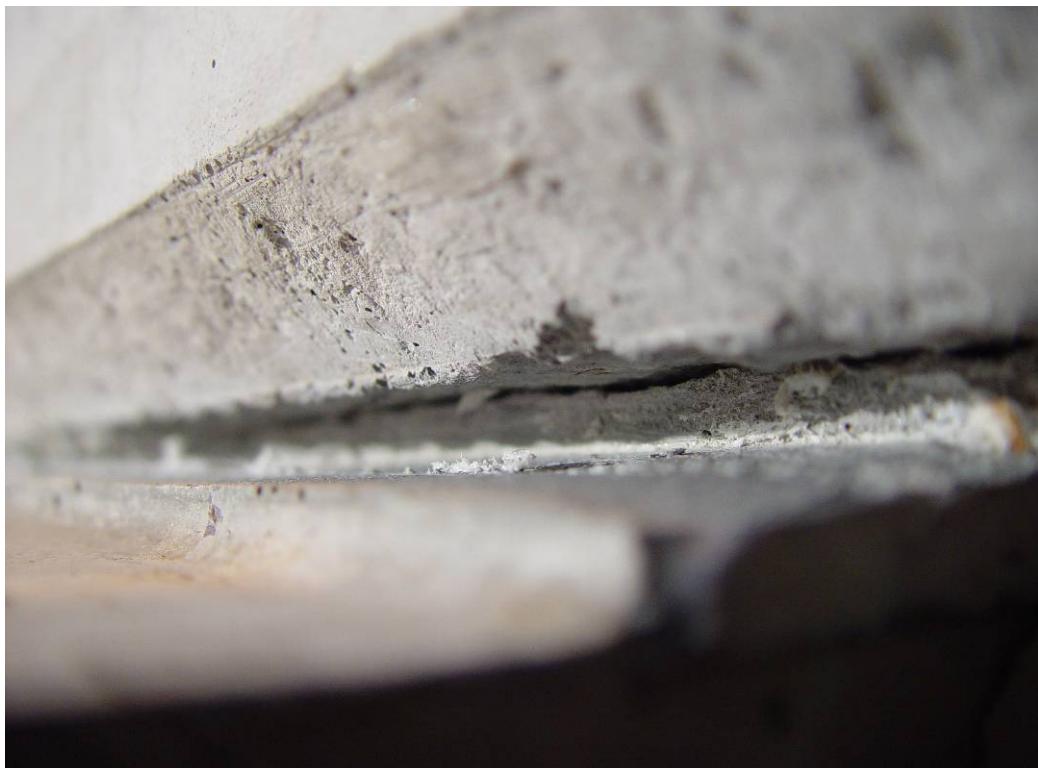
Figure 9-26: Failure of the Composite Interface
