Electrically Isolated Tendons Post-Tension Supplier's Experience

FHWA Workshop at Lehigh University
October 24, 2018

Shahid Islam | Christian Aumann

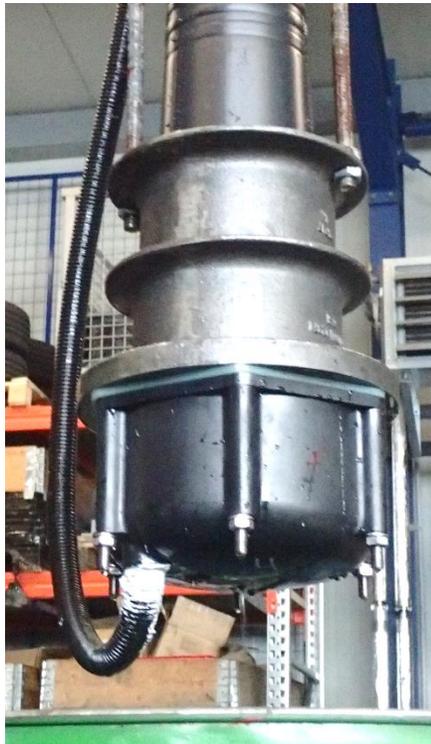
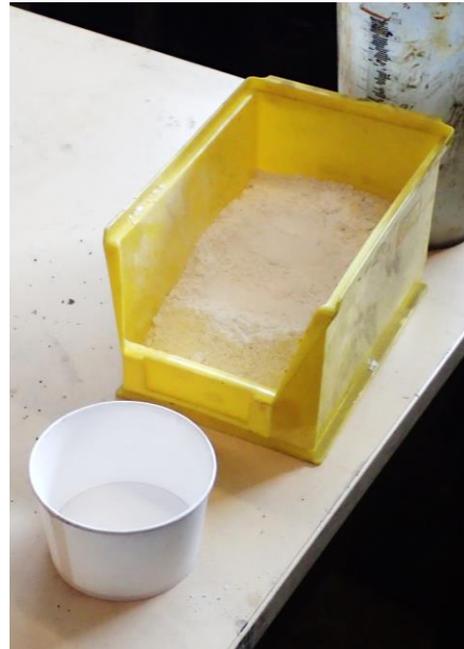
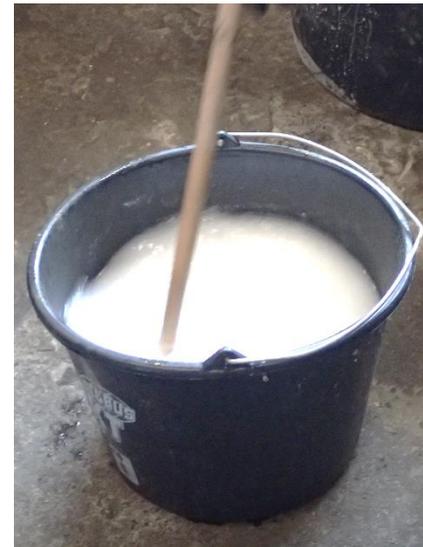
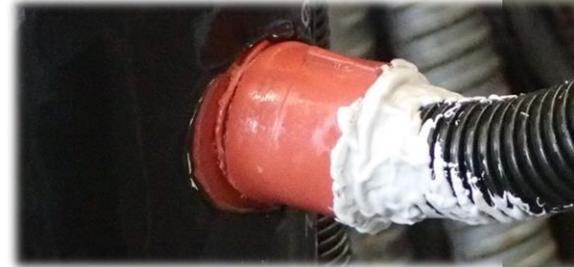
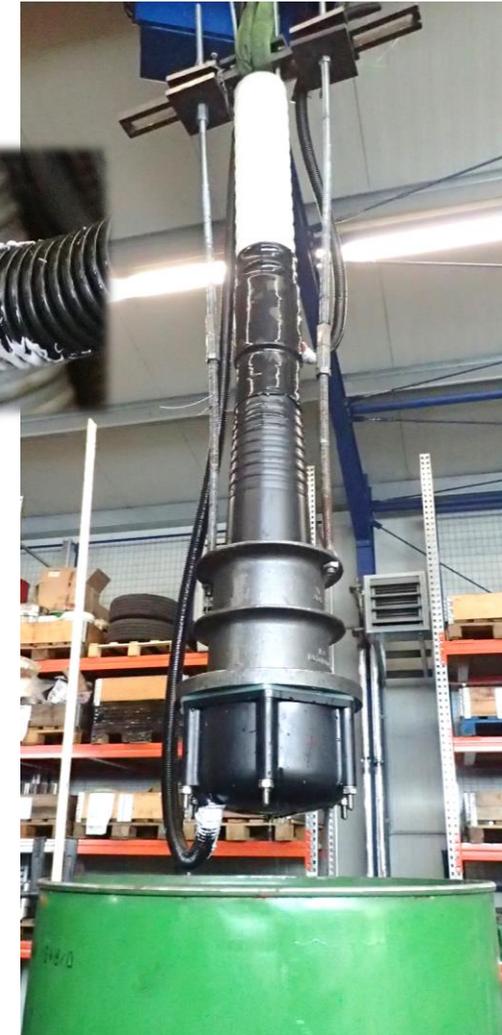
Tightness and EIT-Performance Test

Test Setup acc. to Fib Bulletin 75 for NEW MA-EIT Anchorage Assembly

- Tank with $\text{Ca}(\text{OH})_2$ solution required
- On finished assembly no visible water leaking permitted
- 30 days ≥ 15 kOhm -> Test successfully passed
- External control by Technical University of Munich

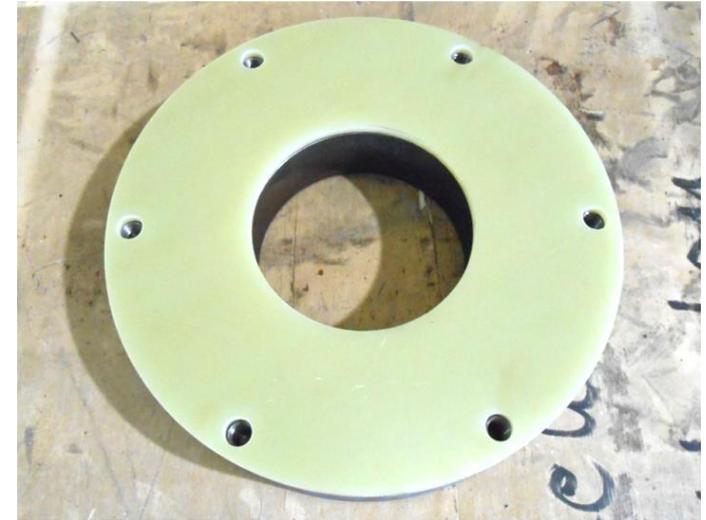
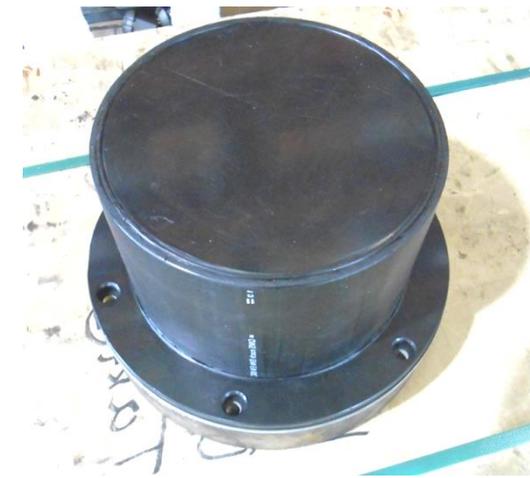
DSI First Generation EIT Plate-Anchorage (ca. 2005)

- Isolation plate providing load transfer from wedge plate to anchor plate and not conducting electricity
- Protection cap made from non-metallic material

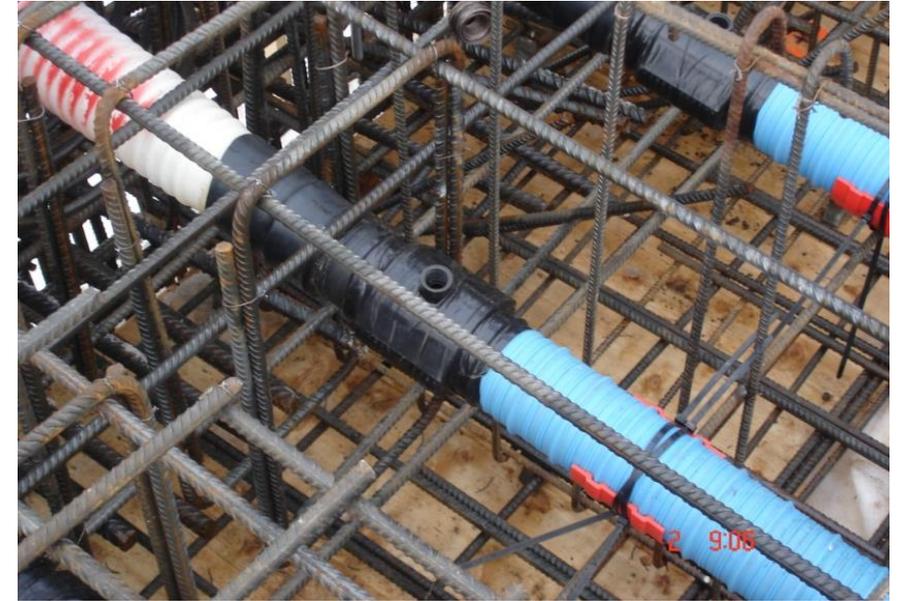
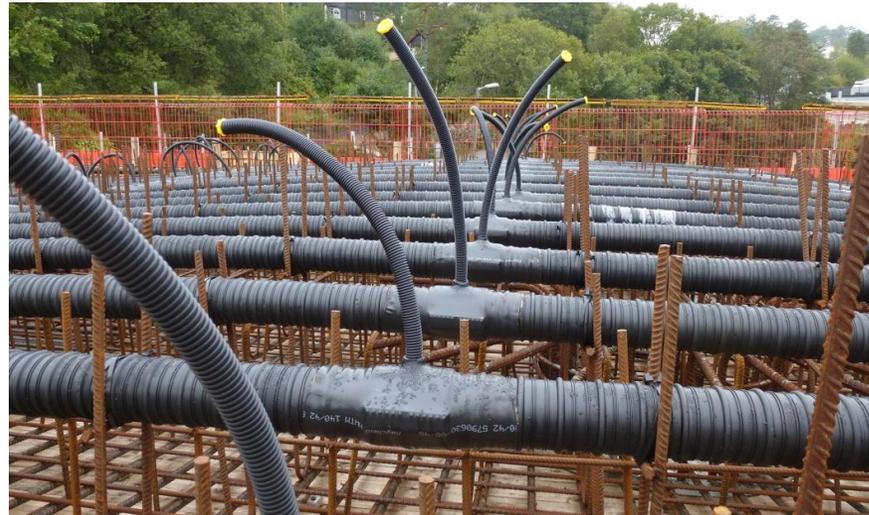
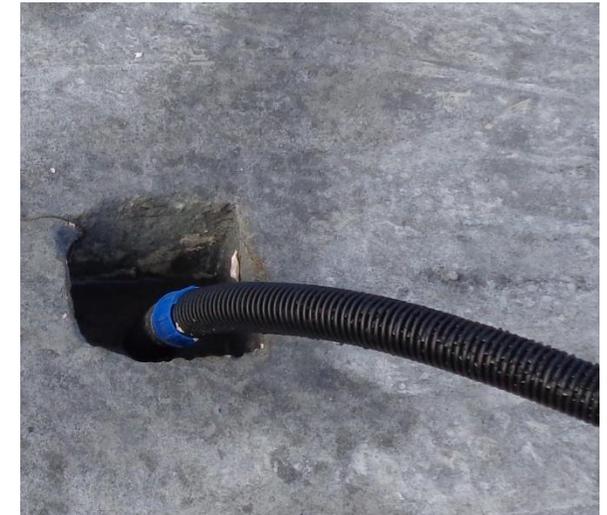
Isolated Duct System

- Duct, transition tube and connector made from plastic with low dielectric coefficient (PP, PE)
- Connections to be sealed with heat shrink sleeves
- Tight fitting of grout/vent tubes and closing-off by plastic caps or plugs
- Block-out at top of slab to trim vent tubes, fit them with a plug and fill the block-out with cement grout

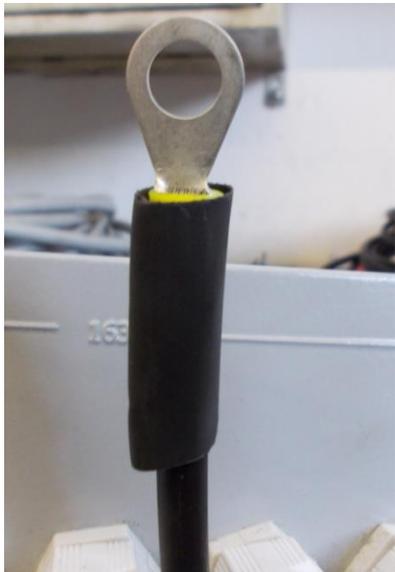
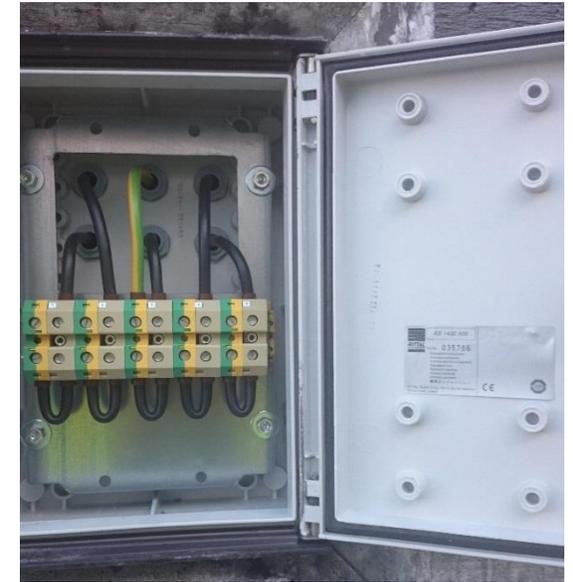
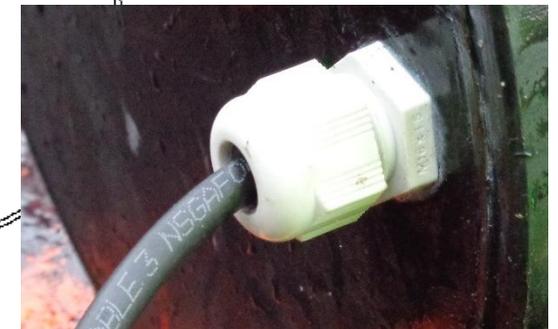
Electrical Fittings for Monitoring

- Measuring cable: connection from anchor to measuring box
- Connection cable: connection from reinforcement to measuring box
- Measuring box: terminals for connection to LCR-meter

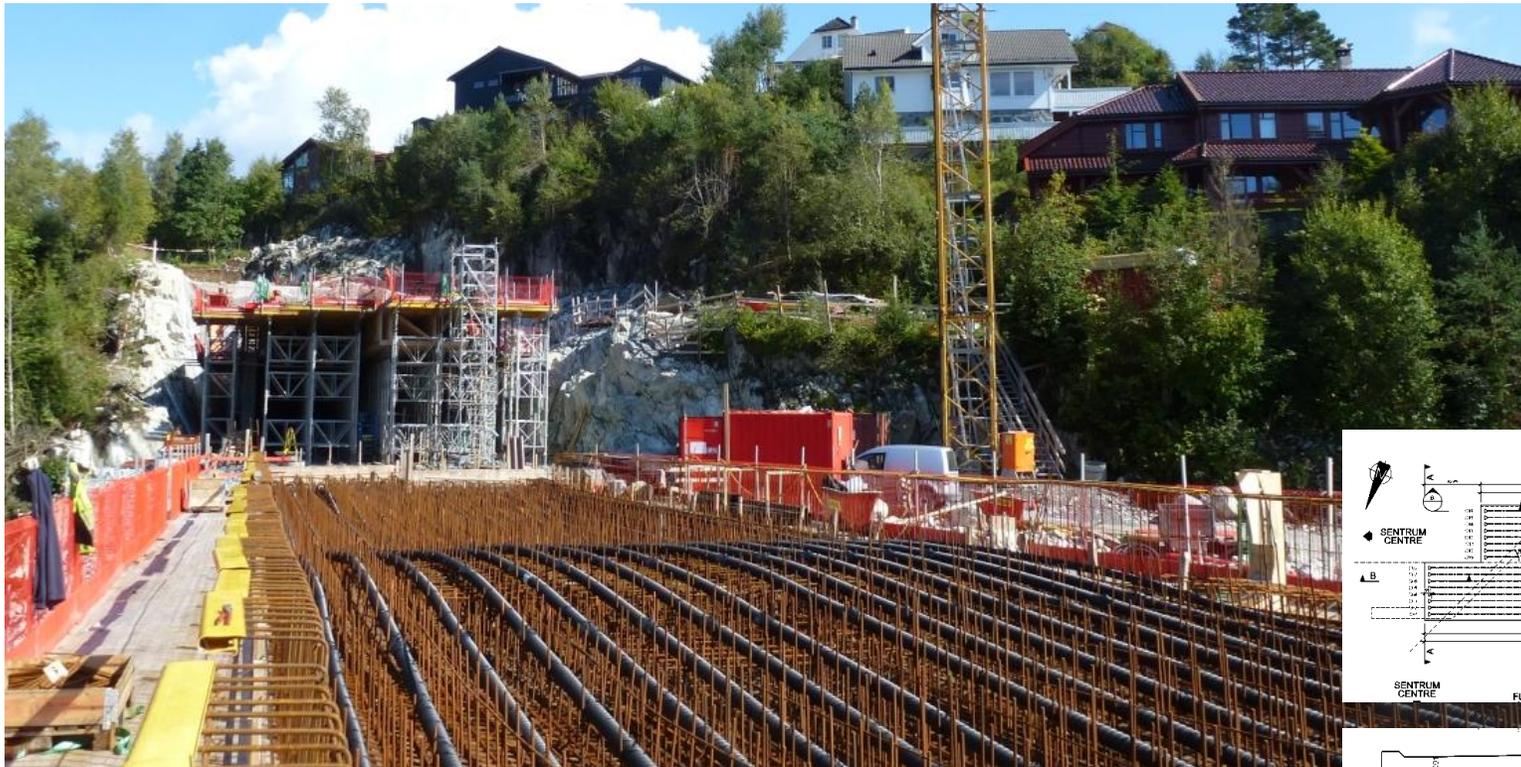
Reference Project: Steinsvik Bridge, Bergen/Norway (2014)

- 16 No. of continuous tendons with lengths ranging from 54m to 59m
- DSI tendons acc. to ETA-06/0025: 2 No. of 12 strand tendons and 14 No. of 19 strand tendons

- Alternating current run tram bridge => EIT specified
- Two-span continuous bridge with spans of 25m and 30m
- Deck width: 8.8m; deck thickness: 0.4m along edges and 1.0m in the center

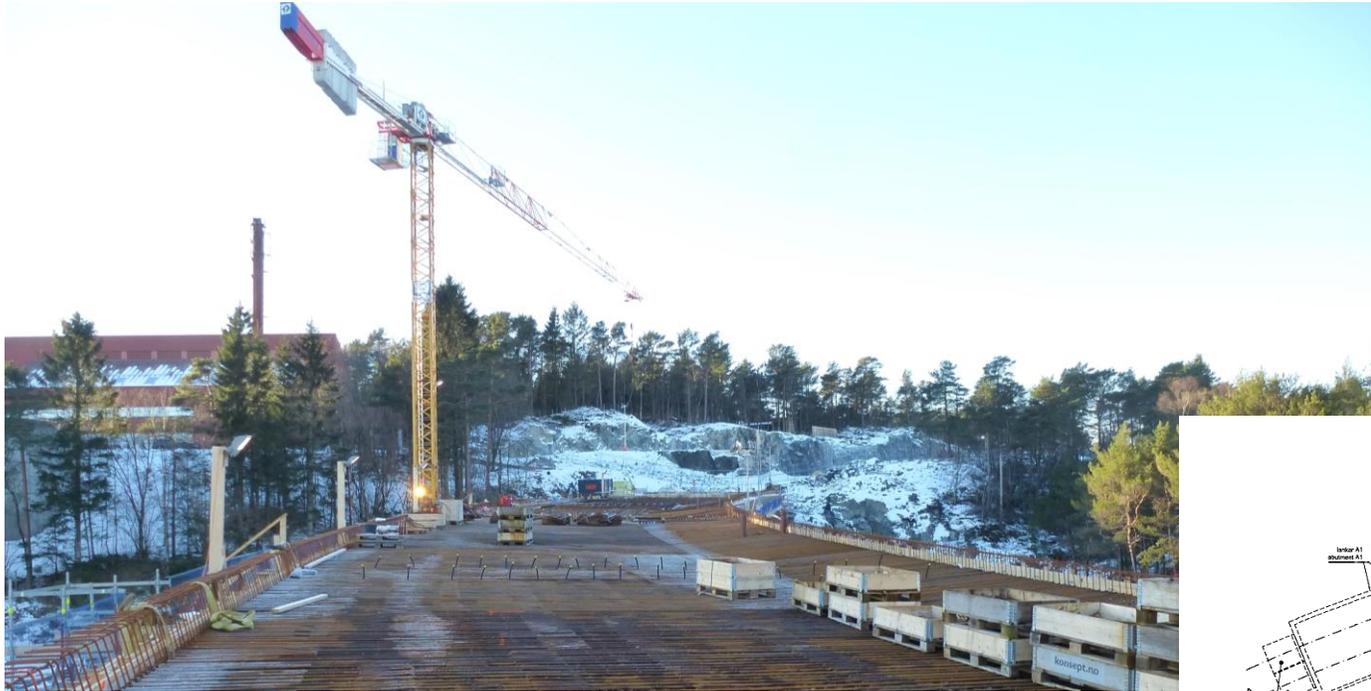
Reference Project: Sandsli Bridge, Bergen/Norway (2015)

- 19 No. of continuous tendons of 19 strand tendons with lengths of 100m
- DSI tendons acc. to ETA-06/0025

- Alternating current run tram bridge => EIT and protection against Stray Current specified
- Four-span continuous bridge with a total length of 100m
- Deck width: 13.5m; deck thickness: varies between 0.5m and 1.3m

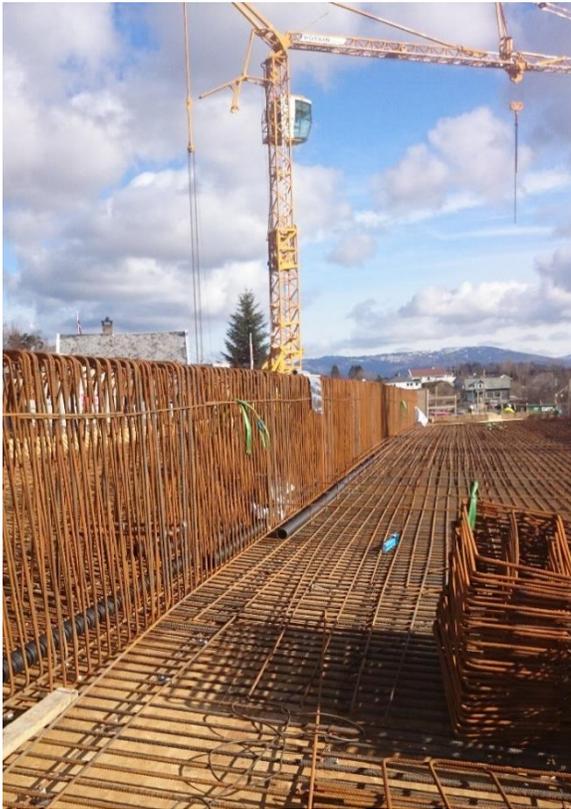
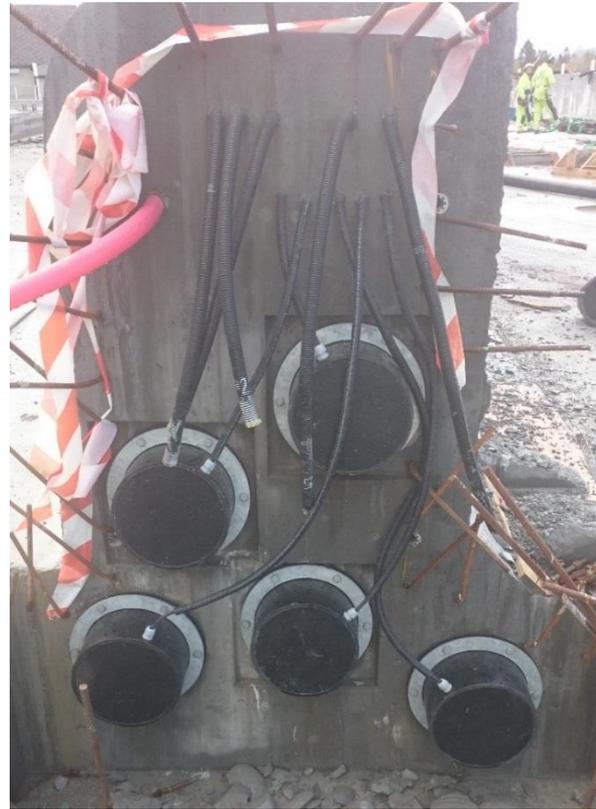
Reference Project: Birkeland Bridge, Bergen/Norway (2015)

- Alternating current run tram bridge => EIT and protection against Stray Current specified
- Single-span bridge with a length of 54m
- Tendons accommodated within parapet girders
- Deck width: 16.4m; deck thickness: 0.27m

- 10 No. of continuous tendons of 22 strand tendon with a length of 54m
- DSI tendons acc. to ETA-06/0025

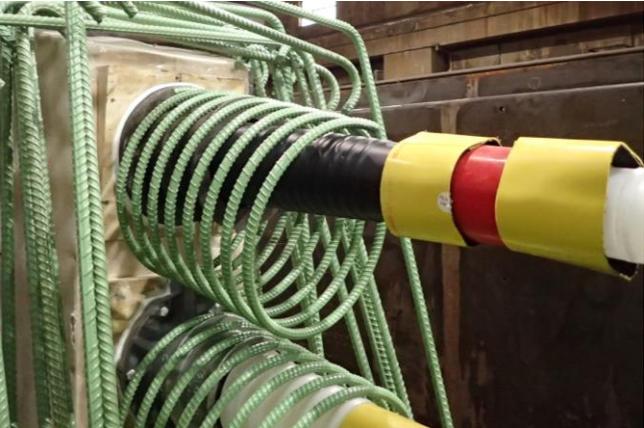
Mounting of Anchorage Assembly

- before shrinking

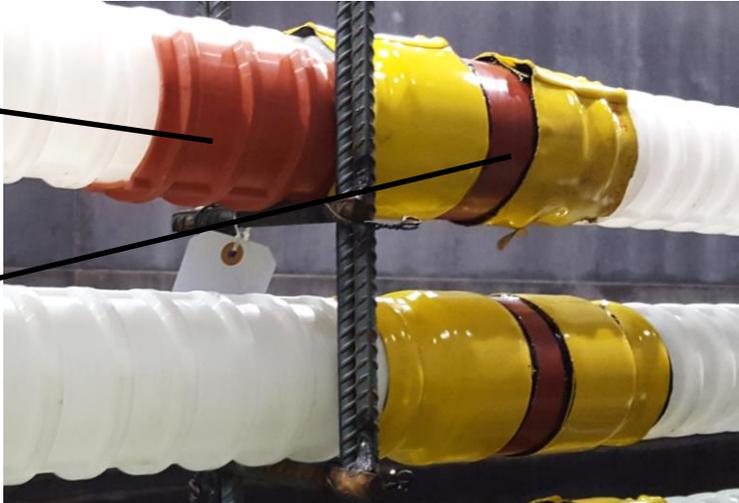
Protection Shell

Duct Coupler with Heat Shrink Sleeve

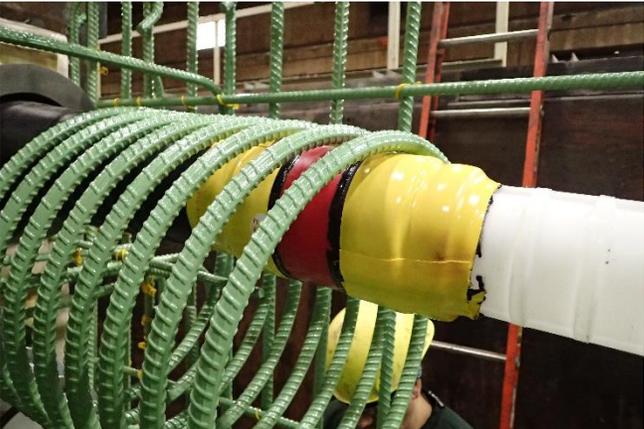
- after shrinking

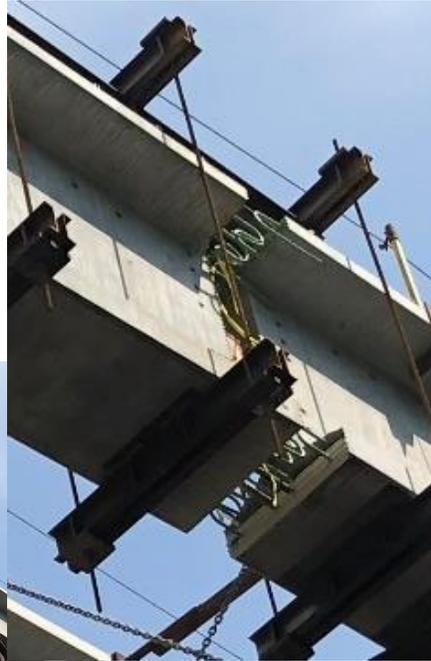
- Installed Girders before CIP Closure

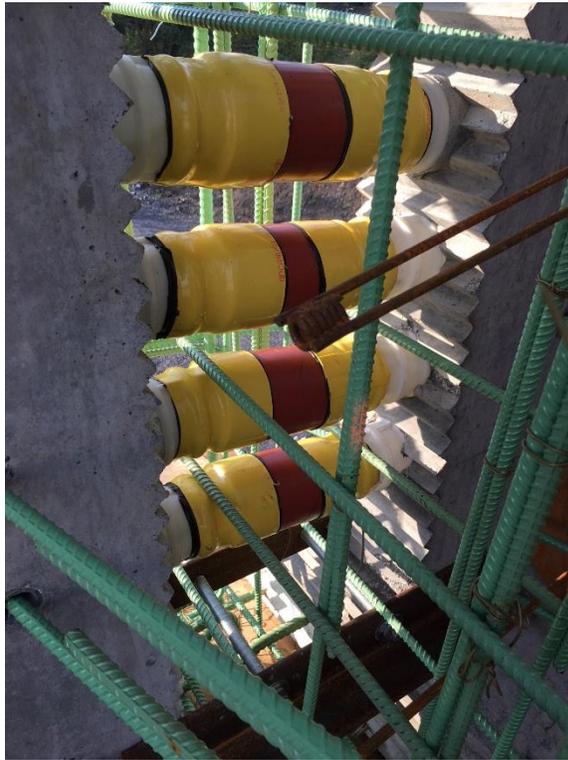
- Duct Coupler at CIP Closure

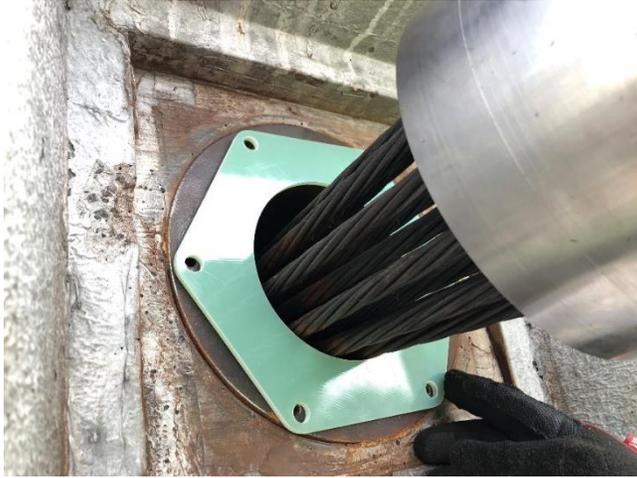
Installation of isolation plate

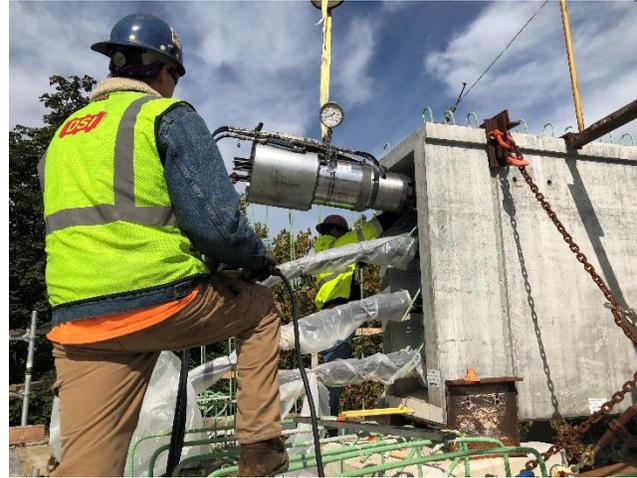
Stressing of tendon

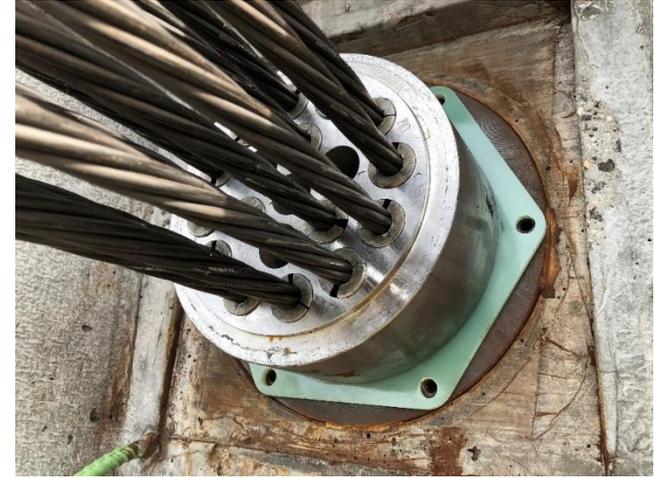
Stressed tendon

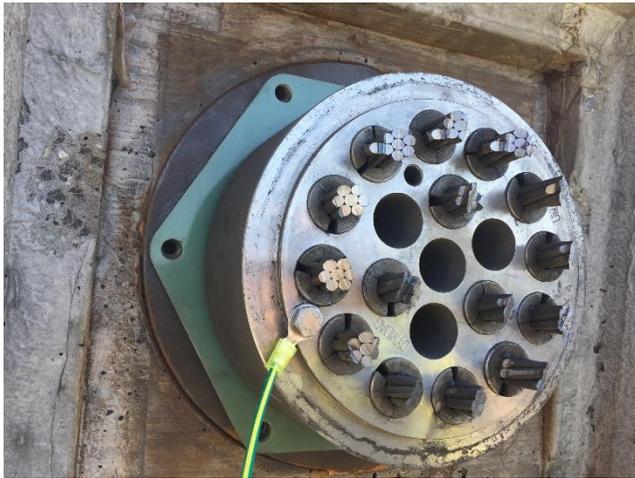
Measuring cable to wedge plate

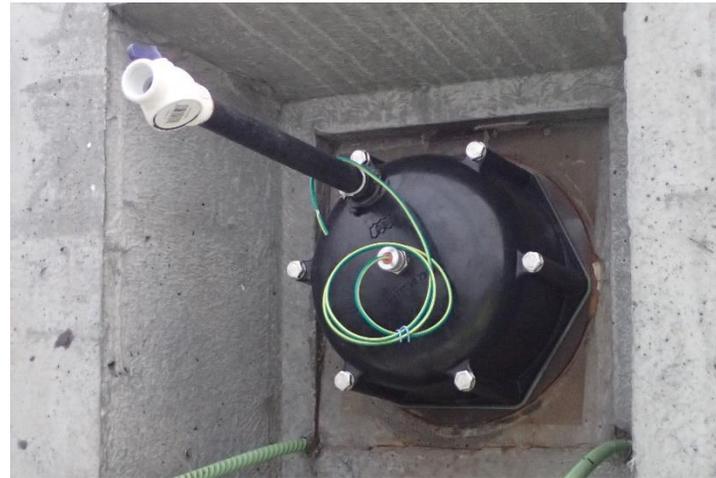
Measuring cable through cap

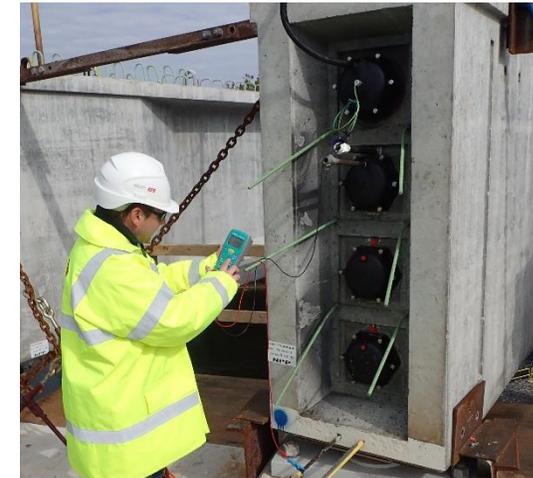
Measuring of Electrical Resistance

Reading on Pier 3	Length [m]	Pre-Grout R		Post-Grout R _l		
		min R ^{*)} [Ω]	Measured [Ω]	min R _{l, 28d} ^{*)} [kΩm]	Measured ^{**)} [kΩm]	Reading taken after grouting [hrs]
Beam B16	166.83	20	172,000	50	53.4	52
Beam B17	166.00		71,000	50	61.4	50
Beam B18	165.31		44,500	50	33.4	48
Beam B19	164.62		166,500	50	42.4	45
Beam B20	163.92		113,400	50	32.3	27

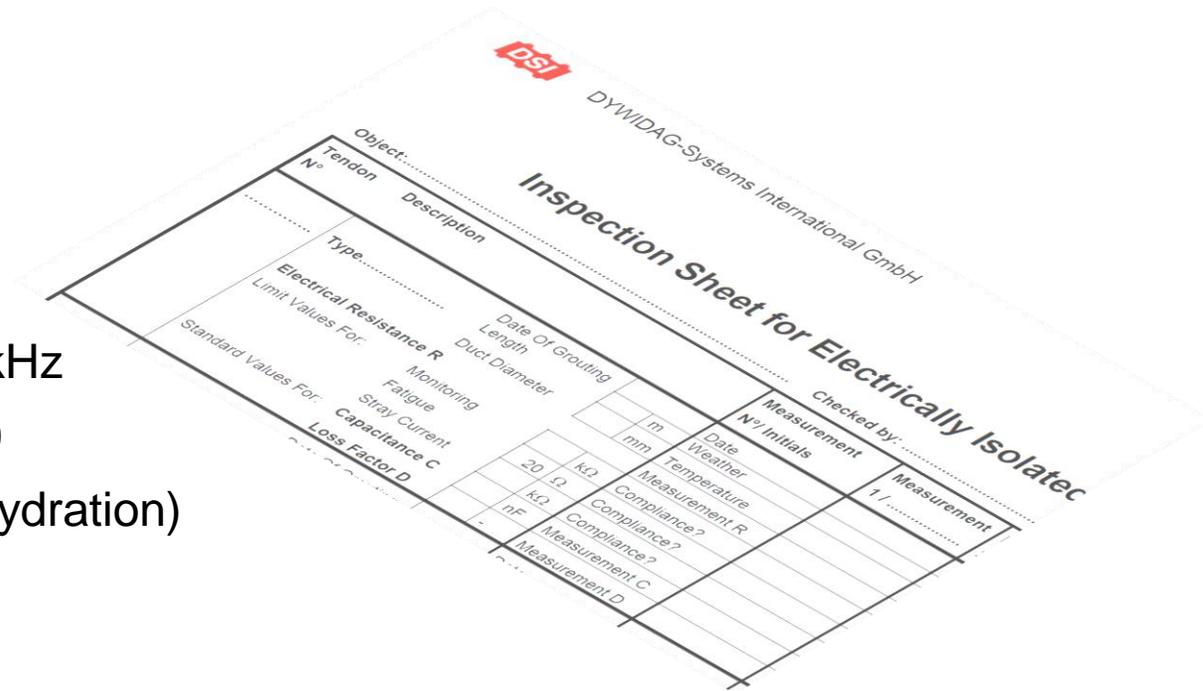
The image shows a tilted inspection sheet from DSI (DYWIDAG-Systems International GmbH) titled "Inspection Sheet for Electrically Isolatec". The sheet contains various fields for recording data, including:

- Object:
- Tendon N°
- Description
- Type:
- Electrical Resistance R
- Limit Values For:
- Standard Values For:
- Capacitance C
- Loss Factor D
- Date Of Grouting
- Length
- Duct Diameter
- Monitoring
- Fatigue
- Stray Current
- Temperature
- Weather
- Measurement R
- Compliance?
- Compliance?
- Measurement C
- Measurement D
- Checked by: N°/Initials
- Measurement
- Measurement
