Year: 2015 Month: 2

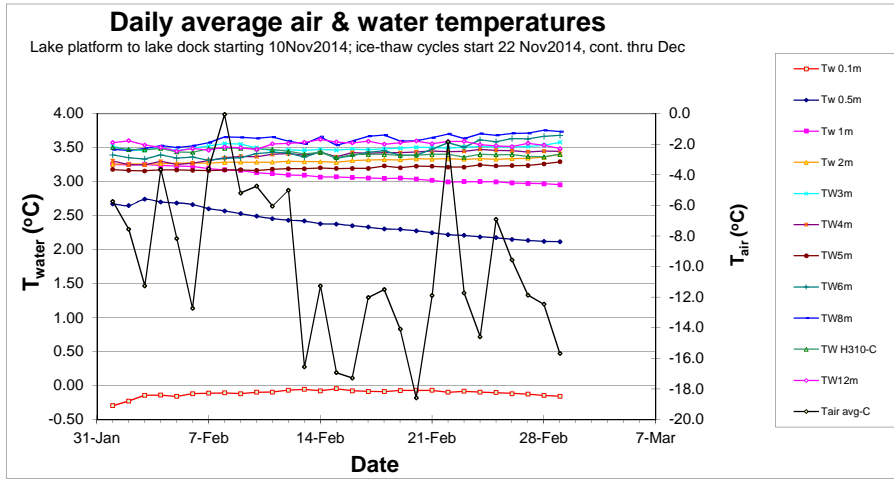
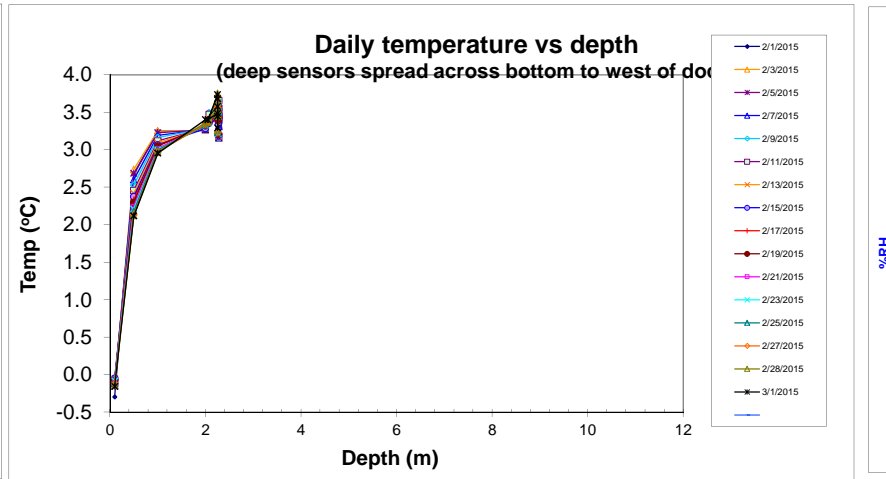
See figure to right for actual d

Lake level is mm above lower edge of dock metal frame (mm of water at 4°C based on pressure)

0.63 inches 1.13 in. precip from Hamlin/Scranton NWS

Precip from rain gage is underestimated during freezing conditions and appears late when air temperature rises above freezing. Lake level rise accurately reflects rain or the water equivalent of snow, plus runoff and snowmelt.
